Manhole Inspection Summary

Manhole # S39W1_025MH

Insp Date: **11/14/07 2:22 PM**

Location Address: **3570 Horton Ave.**

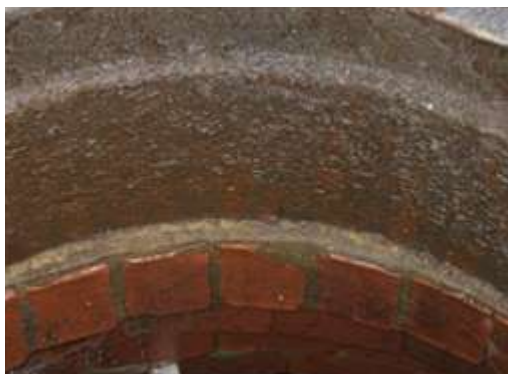
Offset

Frame Offset: **1** (in.) Condition: ☒ Sound ☐ Cracked ☐ Leaks

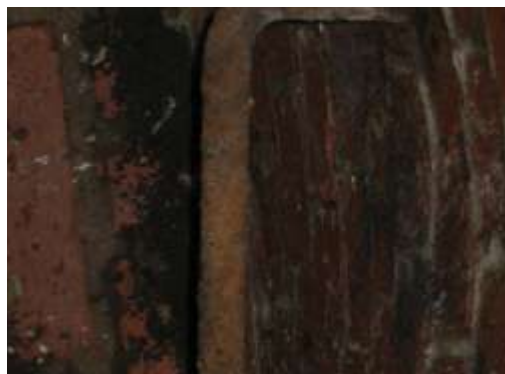
Steps Count: **5** Missing: **0** ☒ **Corroded**

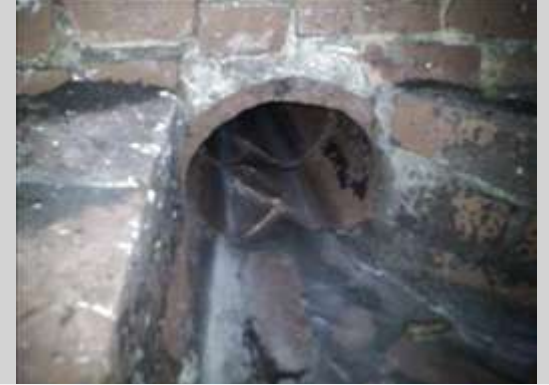
12 O'Clock Outflow

8 in. Circular Gravity Sewer
Pipe Out @ 12 O'Clock

Pipe Height: **8.4** (in.) Rod and Bar (Angled)
Pipe Material: **Clay** ☐ Pipe Lined
Invert Depth: **9.05** (ft.) Flow Characteristics: **Fast**
Deposits: ☒ None ☐ Mud ☐ Sludge ☐ Debris ☐ Grease
Silt Depth: (in.) Deposits Extent:
Infiltration: **Runner** Pipe Seal Cond: **Sound**

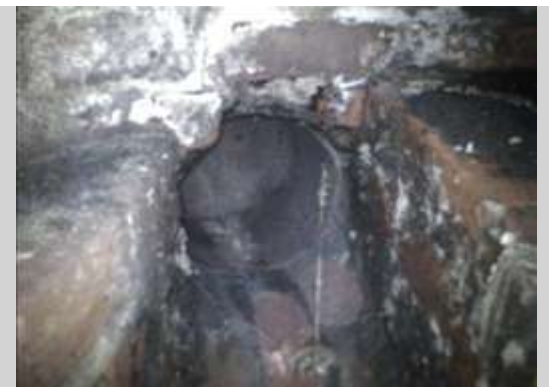
3 O'Clock Inflow

8 in. Circular Gravity Sewer
Pipe In @ 3 O'Clock

Pipe Height: **7.2** (in.) Rod and Bar (Angled)
Pipe Material: **Clay** ☐ Pipe Lined
Invert Depth: **3.27** (ft.) Flow Characteristics: **Slow**
Deposits: ☒ None ☐ Mud ☐ Sludge ☐ Debris ☐ Grease
Silt Depth: (in.) Deposits Extent:
Infiltration: **None** Pipe Seal Cond: **Sound**

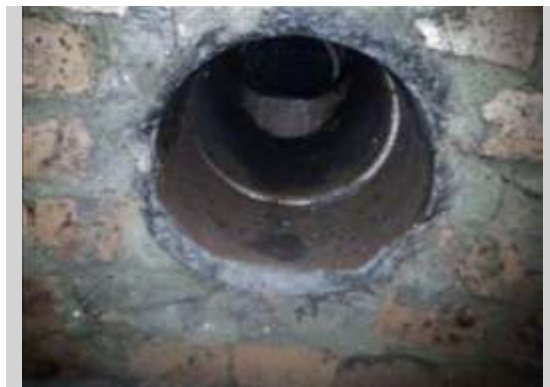
Drop In @ 3 O'Clock

Drop: **Outside** Rod and Bar
Angled: **Yes** Reading: **8.00** (ft.)
Inv Depth: **9.00** (ft.)
Drop Condition: **Open**

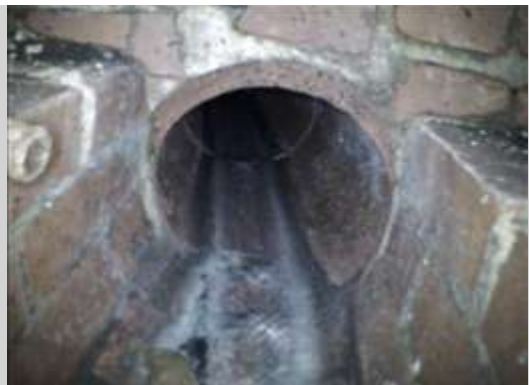
6 O'Clock Inflow

8 in. Circular Gravity Sewer
Pipe In @ 6 O'Clock

Infiltration: **None** Pipe Seal Cond: **Sound**
